DALLWELL FOOT STILE INVESTIGATION STATHERN LEICESTERSHIRE

Report 2024

Part of The Search for Stathern Hall Investigation

STATHERN HISTORIC LANDSCAPE STUDY LEICESTERSHIRE

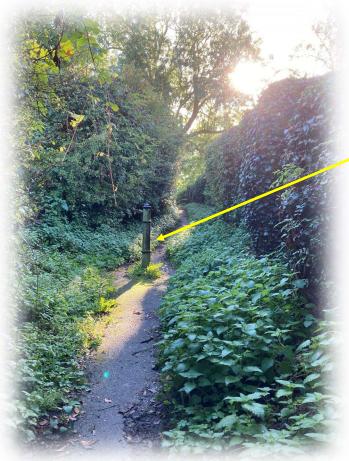
SO, WHY IS THIS HERE?

One of the first things you come across on the way uphill from St Guthlac's church towards the Dalliwell foot stile, is a metal post, fixed into position it would seem for some purpose now lost to history.

What this purpose would have been for remains a mystery.

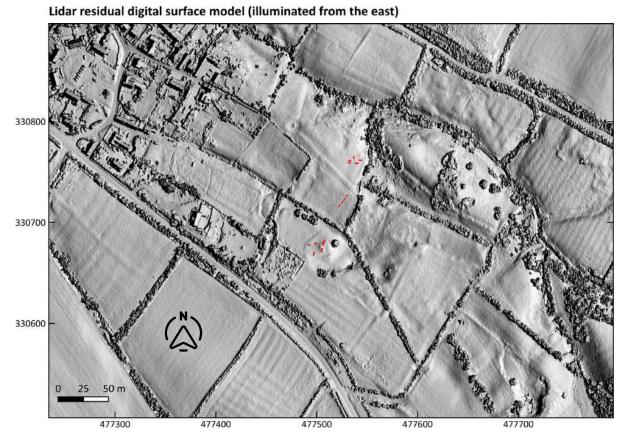
SUPERIMPOSED WITH THE POSITION OF THE FLAG TRENCHES

Showing the suggested location of the FLAG trenches as featured in the 2023 Search for Stathern Hall report

Note: The Lidar image shown above includes vegetation and buildings, and the one featured below shows the same area with the vegetation and buildings removed

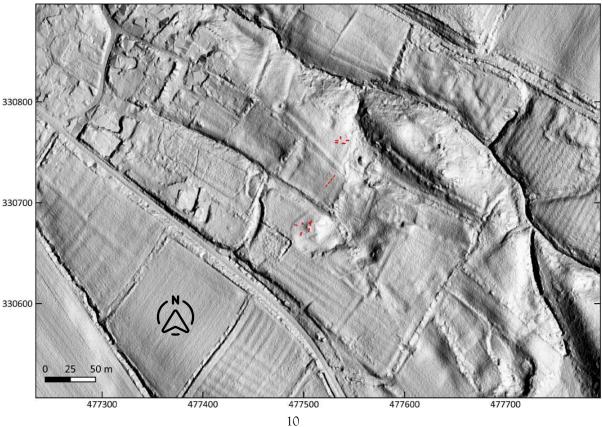
Lidar residual digital terrain model (illuminated from the east)

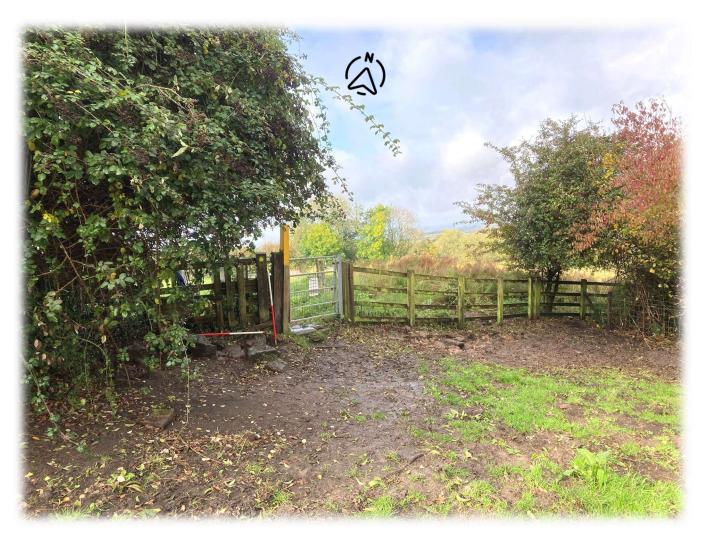
The image above shows both sides of the Dalliwell foot stile cleared of foliage, and the exposed layer of rubble on the Coombs Meadow side of the wooden boundary fence.

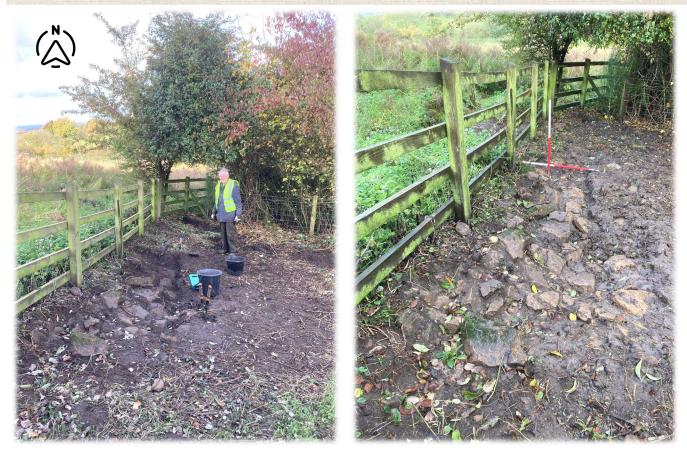
The two images featured above, show the stone rubble layer on the Coombs Meadow side of the wooden boundary fence in more detail. Roger can be seen pictured, providing a degree of scale.

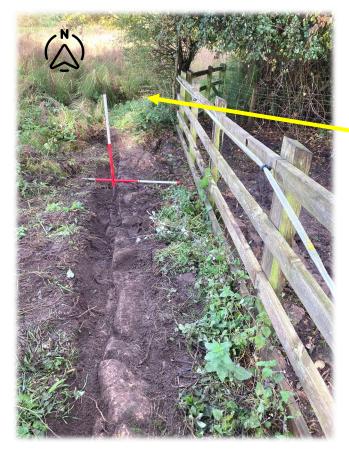
The image to the left, shows the newly discovered stone wall sitting just beneath the soil on the neighbouring side of the Coombs Meadow boundary fence.

The remains of this wall have been pushed over towards the line of the Coombs Meadow boundary fence.

The image featured above, shows an area of the wall that warrants further investigation.

Does the wall continue, does it end here or, does it turn?

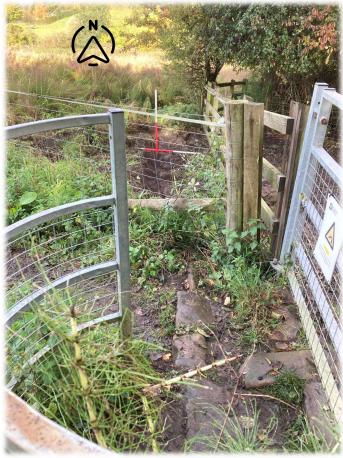
The image featured below provides a view from the village approach to the Dalliwell foot stile.

Note how steeply the hill falls away to the north side of the stile. The question is; how much of the slope did the

boundary wall encompass?

This is another landscape mystery that would warrant further investigation.

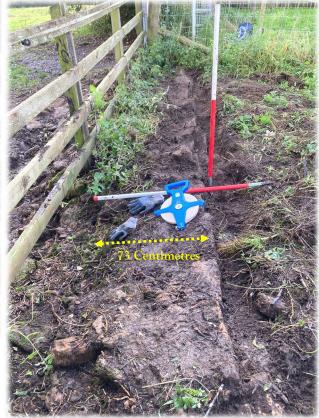
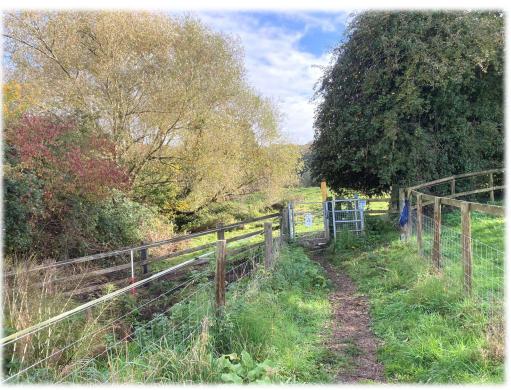
The Dalliwell foot stile investigation has proved to be a success, and has moved us one step closer to finding Mr Hacker's home. The images featured left and below show that the newly discovered stone wall sited on the neighbouring side of the Coombs Meadow wooden boundary fence, connects with the remaining stone wall sitting beneath the modern day Dalliwell foot stile.

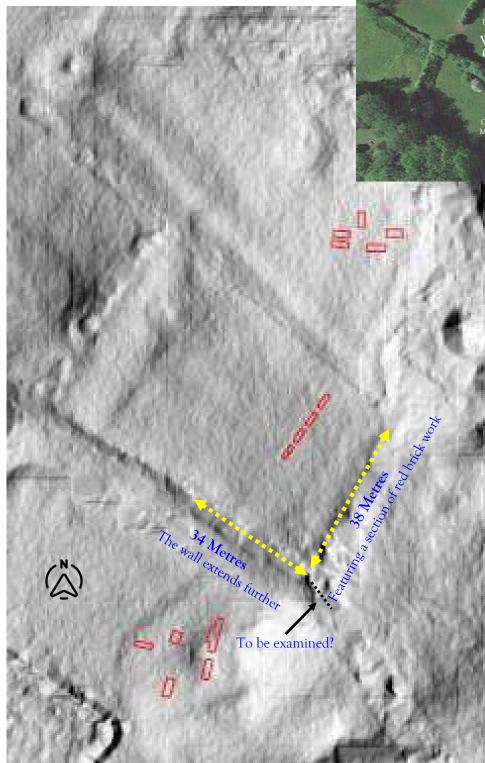
Thanks to the kind permission of Sally and Bob Wadsworth, The Field Detectives were able to examine the remaining stone walls that line the edges of the horse paddock as shown on the image below.

The Lidar image featured below captures the wall measurements and their proximity with the earlier FLAG archaeological trenches.

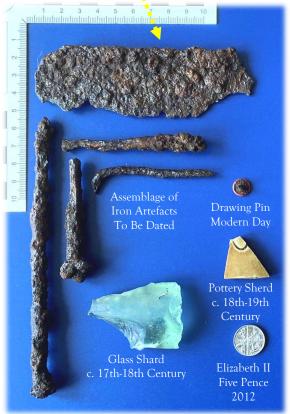
The artefacts shown above were found halfway down the Coombs Meadow wooden boundary fence. They were in the soil removed to reveal a layer of stones that were pushed off the top of a stone-built boundary wall situated on the other side of the fence.

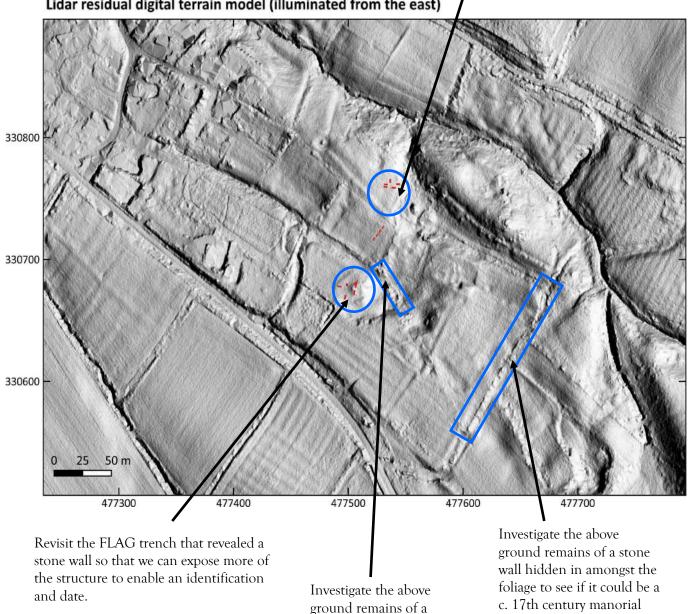
The Lidar image featured below, has been used to highlight the next phases of the Search for Stathern Hall investigation if permission can be obtained to progress them. Our research tells us that the building we are looking for will be more like a large farmhouse than a high status hall. Most probably best described as a Manor House.

Lidar residual digital terrain model (illuminated from the east)

Seek permission from the landowner to investigate the stone built boundary wall heading north from the Dalliwell foot stile gate to determine the extent of the manorial estate boundary.
